Manhole Inspection Summary

Manhole # S06GG2013MH

Insp Date: **7/29/06 8:18 AM**

Location Address: **3401 BONNIE RD**

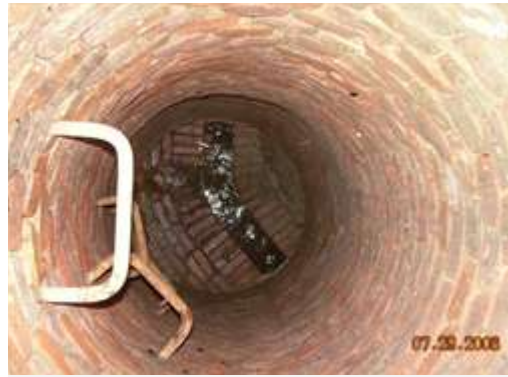
Top View

Infiltration: ☐ None ☐ Joint ☐ Cracks ☒ **Mortar** ☐ Roots ☒ **Wall**

☒ **Debris** (not Condition related)

☒ **Corroded**

Barrel infiltration. Corroded steps. Bench debris.

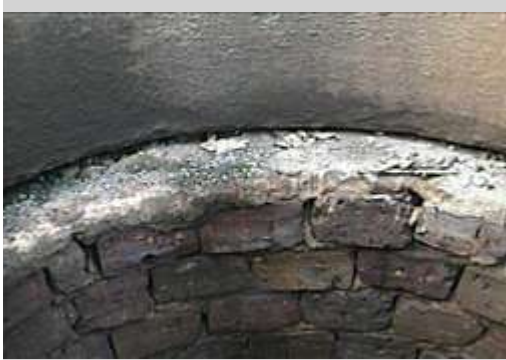
Defect

Offset: **3** (in.)

☒ **Leaks**

Condition: ☐ Sound ☐ Cracked ☐ Root Intrusion ☒ **Loose Brick** ☒ **Deteriorated**

Infiltration: ☐ None ☒ **Joint** ☐ Cracks ☒ **Mortar** ☐ Roots ☐ Wall

Frame leaks. Frame offset. Adjustment deterioration, loose brick and infiltration.

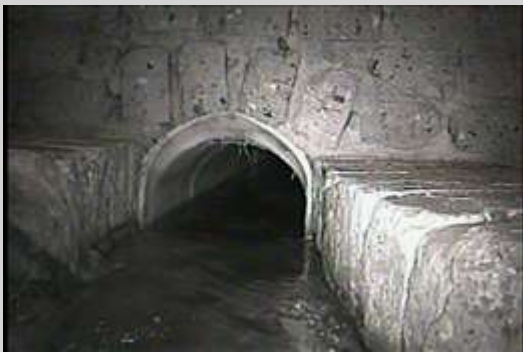
8 in. Circular Gravity Sewer Pipe Out @ 12 O'Clock

Condition: ☐ Sound ☐ Cracked ☐ Root Intrusion ☒ **Deteriorated** ☐ Leaks ☐ Debris

Bench and Channel deterioration.

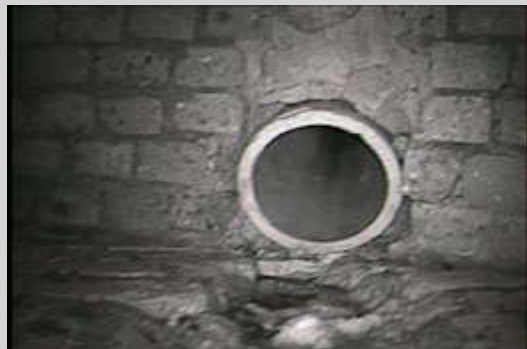
8 in. Circular Gravity Sewer

Infiltration: **Evidence**

Pipe Seal Cond: **Broken**
